# Analysis of the Data from the YAOKI Rover on the IM-2 Mission to the Lunar South Pole

**Summary:** This document provides the analysis of the data from the YAOKI rover on Intuitive Machine's IM-2 mission. It focuses on correlating the telecommands sent and the telemetry received to showcase the technology validation of the Dymon rover and the JAOPS command and control system in the lunar surface environment. This analysis emphasizes lessons learned to be implemented in the next missions.

## YAO KI IM2 Data Analysis

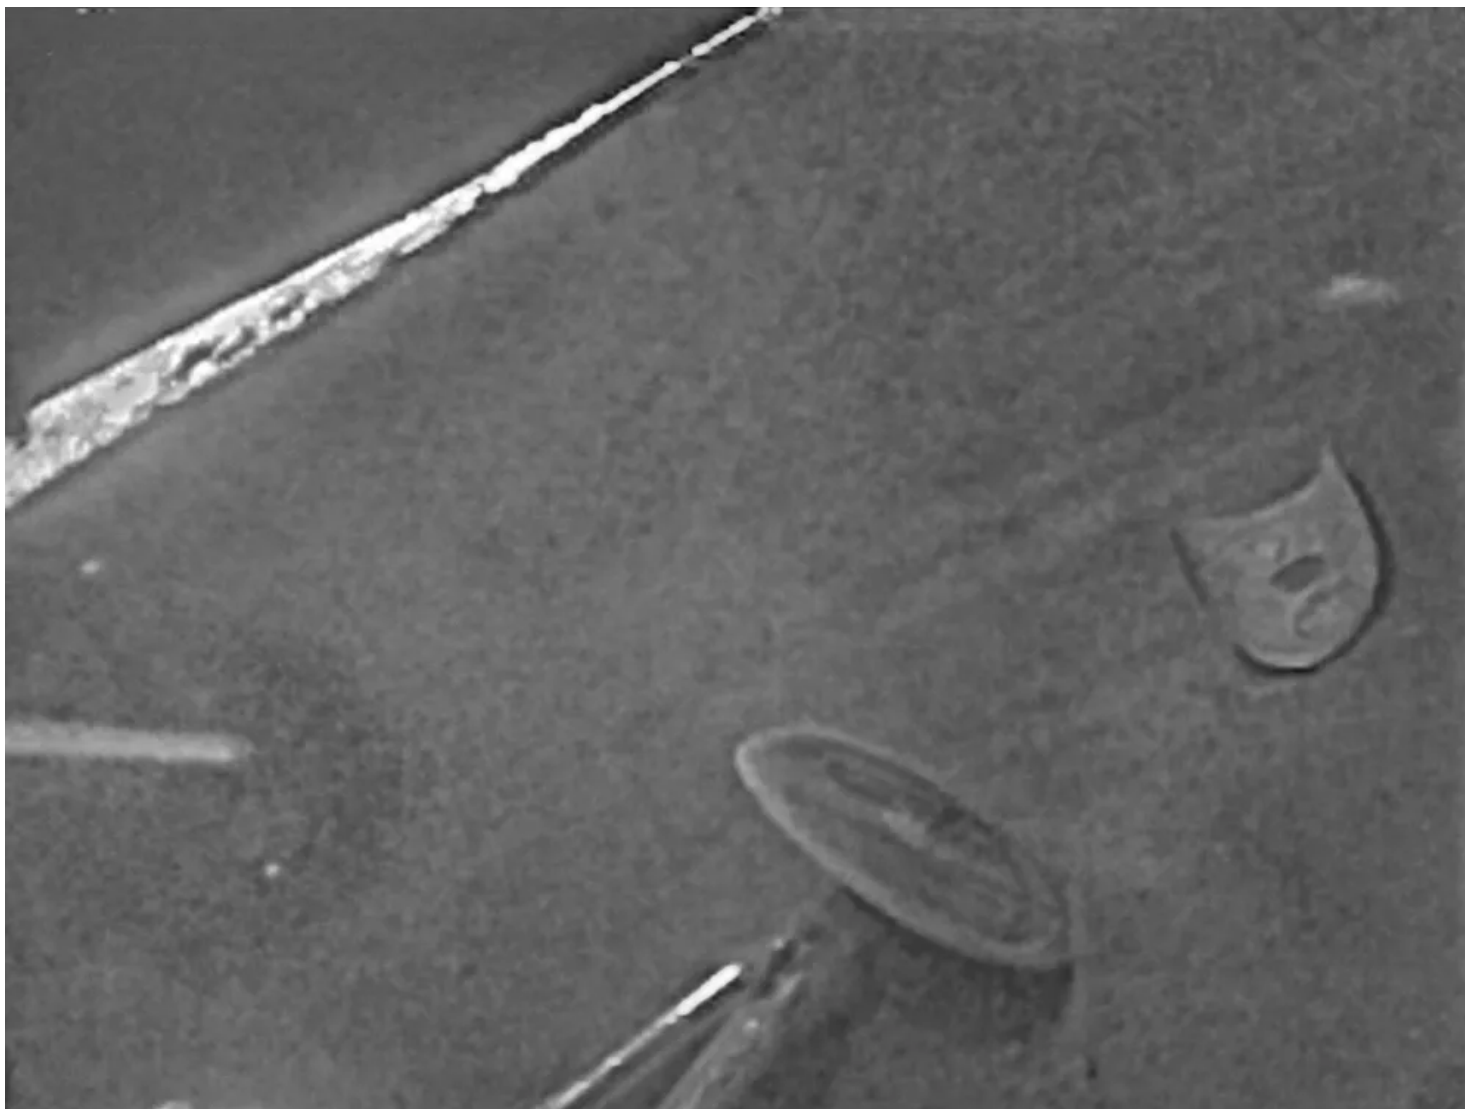
More advanced (and destructive) processing reveals additional features:

Center right: appears to be the sticker of the footpad that peeled off and curled up. The Arizona and Maryland logo is somewhat visible

Above right: appears to be a rock

Center between the main leg and the sticker: linear regolith pattern

Center left: appears to be another (broken?) lander leg

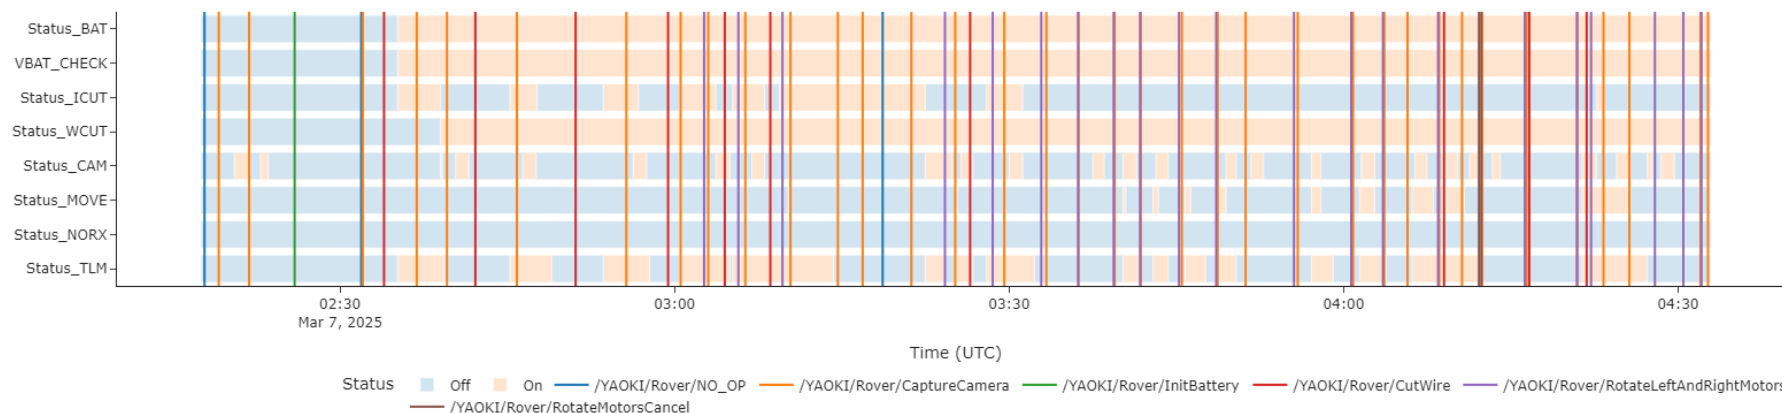
YAOKI Rover Status + Telecommands

The entire overlay of the commands and the status bits is given below:
